Heavily Modified Waters in Europe

Case Study Wienfluss

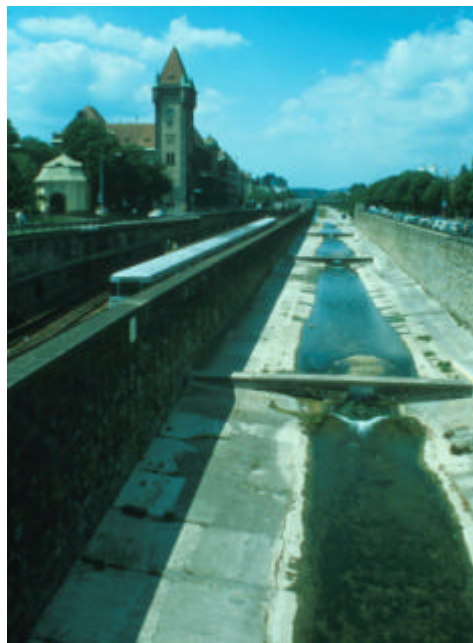
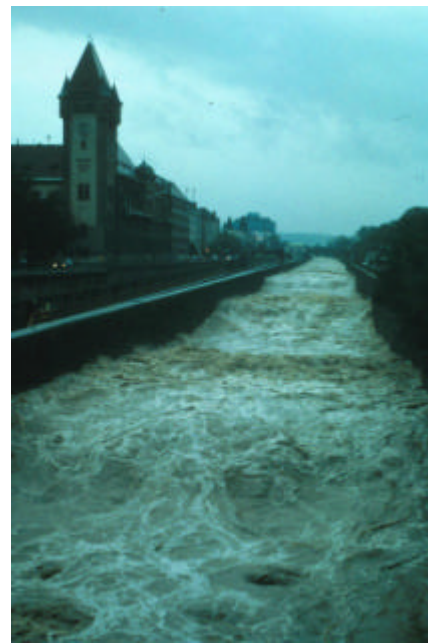
Figure 2 Downstream section of the Wienfluss at low water level and during the flood event of 1992. Due to the geological situation in the catchment area (Viennese sandstone, Flysch) there are great differences between low and high water levels.

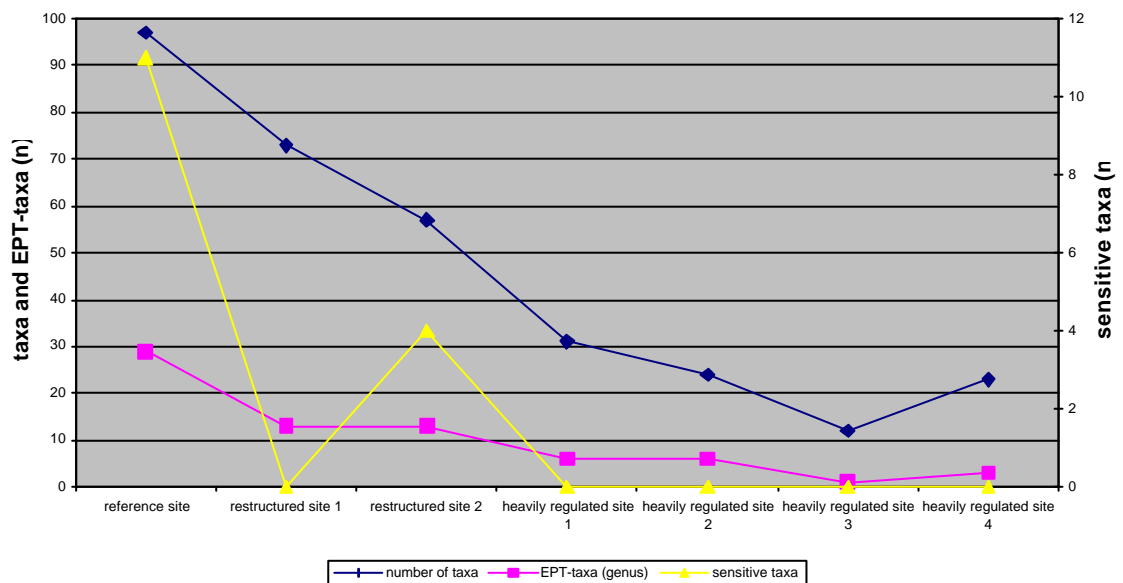
Figure 5 Comparison of a nature-like site (Mauerbach), two restructured sites (upper section Wienfluss) and four strongly impaired sites (downstream section Wienfluss; data from Gattringer, 2002)

The number of species decreases from the upper to the lower part of the river.

On the other hand the few species in the low structured lower reach show higher abundances than the species in the upper reach.

Hence the mean species number decreases from the heterogenous upper reach to the homogenous and monotonous lower reach.

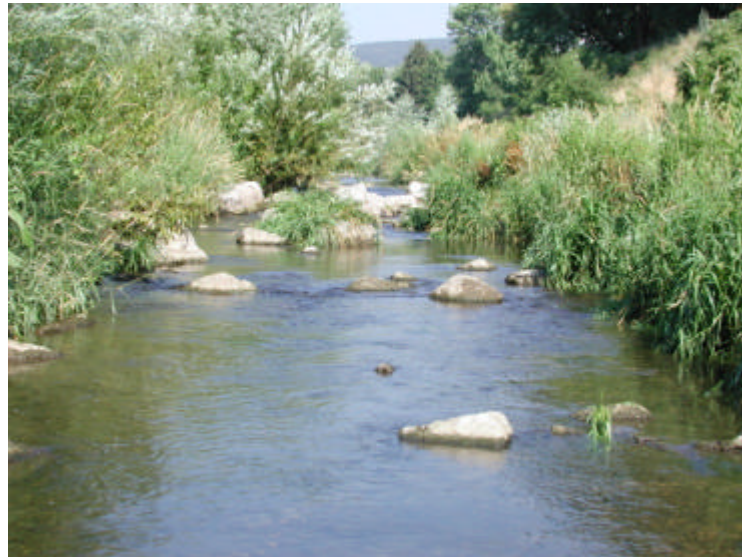
Fig. 7 Rehabilitation measures increasing habitat diversity in upper section of the Wienfluss

The rehabilitation measures so far taken in Wienfluss show that it would be possible to attain the target "good ecological potential", set by the EU WFD, provided that these measures are extended to the entire Wienfluss stretch.
